**Be careful not to install wear discs between the fifth wheel top plate and the semi-trailer rubbing (skid) plate**

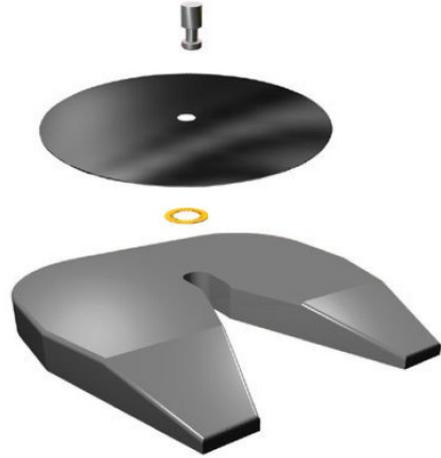
This is an extremely dangerous practice and is to be avoided at all costs as it could have serious or even catastrophic consequences. To mention only a few potential dangers: -

- In most instances this wear disc is fixed to the kingpin and covers the rubbing plate of the semi-trailer. This makes it impossible to visually determine damage to the semi-trailer rubbing plate during routine maintenance inspections, unless the wear disc is physically removed from the semi-trailer rubbing plate. A damaged semi-trailer rubbing plate that goes unchecked could damage the fifth wheel beyond repair and could even collapse altogether, resulting in the semi-trailer detaching from the fifth wheel.

- The wear disc interferes with the gap between the upper and lower shoulders of the kingpin and the lockjaw of the fifth wheel. This could result in a miss-coupling and, as the semi-trailer is not securely coupled to the fifth wheel, the trailer could drop off from the fifth wheel at any time during travel. Should the kingpin height be increased to accommodate for the thickness of the wear disc it will result in an increased bending moment on the kingpin, increasing the forces and stresses acting in on the kingpin. The kingpin will also no longer conform to S.A.B.S. specifications.

- As the wear disc is only secured to the kingpin, the outer circumference of the wear disc hangs loose and could get rolled up between the semi-trailer rubbing plate and the fifth wheel top plate during the coupling process, resulting in a miss-coupling with the same disastrous consequences as mentioned in the previous point.

- In side tipper applications the bending moment caused by the upwards moment of the kingpin during the tipping cycle is increased as there is no play between the bottom shoulder of the kingpin and the underside of the lockjaw. This could result in the bottom shoulder of the kingpin shearing off where it is in contact with the lockjaw and/or the fifth wheel top plate cracking through the centre and ultimately failing completely.

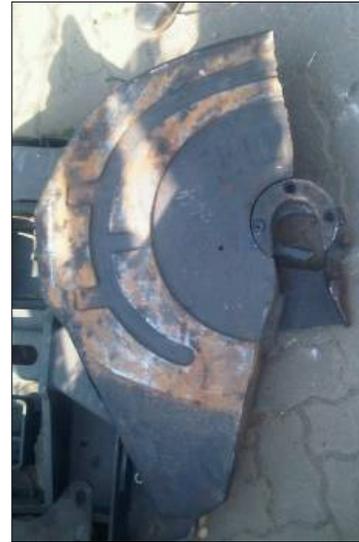
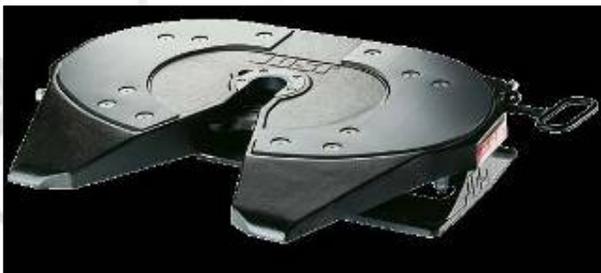
A much safer alternative to the fitting of a separate wear disc will be to use a JOST JSK37CW low maintenance fifth wheel with a Lube-Tronic automatic lubricator fitted to the fifth wheel (this option is only suited to on-road applications and not for side tipping applications). This fifth wheel is fitted with “built in” plastic liners which is bolted onto the fifth wheel top plate and visual inspections of the semi-trailer rubbing plate, once the semi-trailer is uncoupled from the wheel, is still possible.

These plastic liners do not require greasing, only a thin layer of oil which is spread over the Teflon liners to prevent the semi-trailer rubbing plate from “biting” into the liners and to facilitate ease of steering. This results in a much cleaner operation.

The plastic liners, once worn down, can easily be replaced (without having to remove the fifth wheel top plate from the pedestals) at a fraction of the cost of a new fifth wheel and will not damage the semi-trailer rubbing plate. Once the liners are replaced, the fifth wheel is restored back to its original condition. Needless to say, wear checks on the high wearing components (lockjaw, wearing ring and kingpin) must still be conducted at regular intervals.

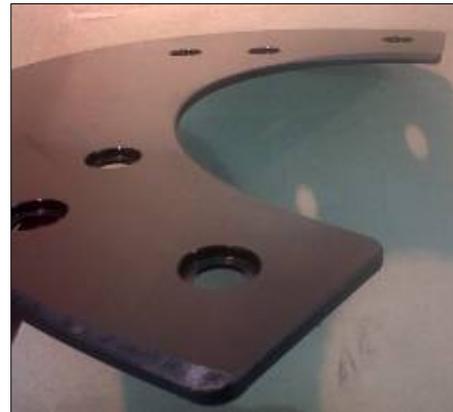
The wearing ring of the JSK37CW low maintenance fifth wheel is also equipped with a plastic insert which can be replaced once worn down. This plastic insert in the wearing ring protects the top shoulder of the kingpin, reducing wear.

The height of the JSK37CW fifth wheel is specifically designed to suit the standard height of a 2” kingpin.

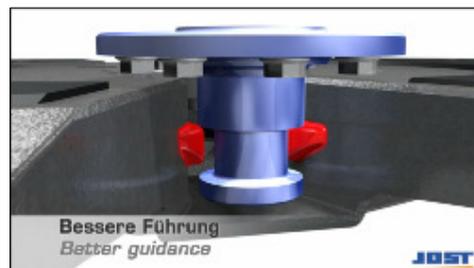
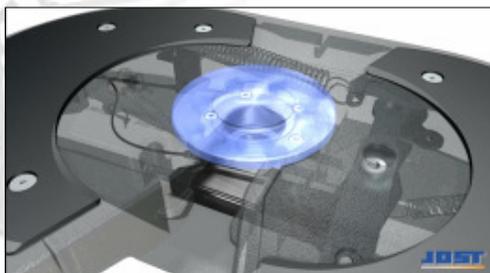
Eliminating the possibility that a miss-coupling could occur as a result of interference in the gap between the lockjaw and the top and bottom shoulders of the kingpin.

The Lube-Tronic lubricator, once activated, will provide a sufficient amount of grease to the lockjaw to ensure that wear between the lockjaw and the kingpin is minimised and will keep the lockjaw lubricated for up to three years.
