## Untraceable fifth wheel spotted in Gauteng

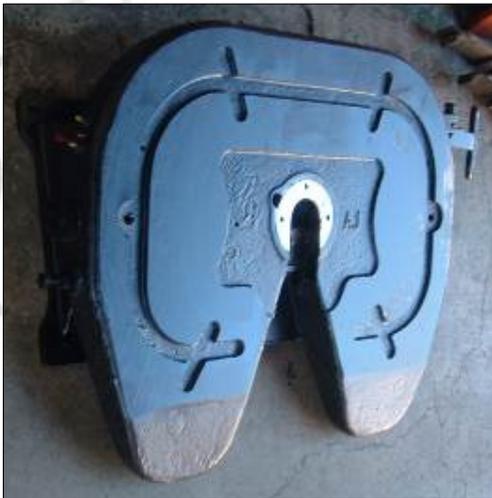
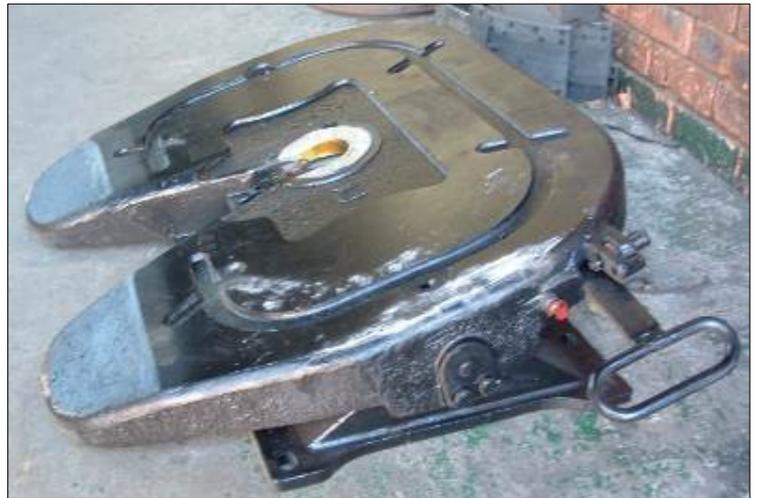
Here are some pictures of just such a fifth wheel spotted in the Gauteng area.

There is no name plate, no batch number, no serial number, no max imposed load rating, no max D-Value rating, no max GCM rating, no date of manufacture, no origin visible anywhere on this fifth wheel.

This fifth wheel is not legal and is not allowed to be fitted on any South African licensed vehicle. Any vehicle fitted with this unit will not be able to pass COF.

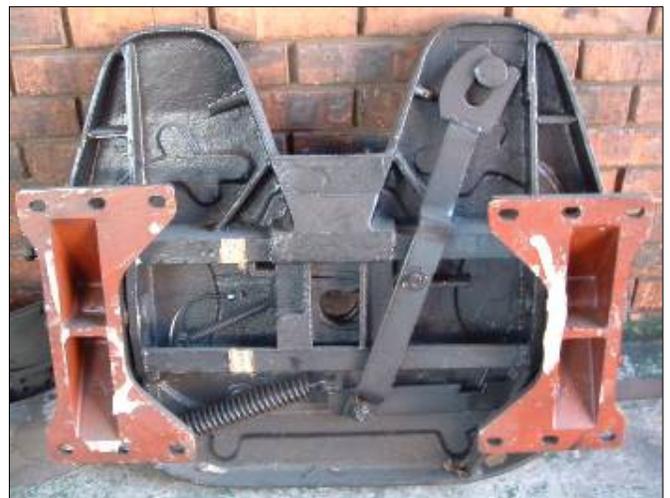
The following question is: where would you find spares for this fifth wheel, and how do you maintain it? On closer inspection it was found that Jost spares do not fit in the locking mechanism of this untraceable fifth wheel.

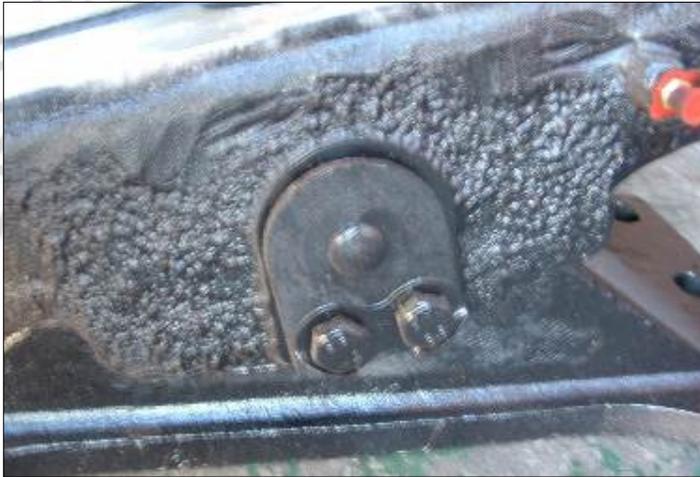
Looking at South African conditions and applications it is also important to match the strengths and weaknesses of the fifth wheel to the environment it has to operate in. This fifth wheel has an E-Type mounting on the pedestal (pin and bush). As South Africans we are all aware of the deteriorating road conditions in the country. The only thing standing between the shock load of the trailer and the drivetrain of the towing vehicle is the shock absorption offered by the fifth wheel. In this case with the pin and bush type mounting as seen here, there will be little to no shock absorption offered by the fifth wheel.

The damage resulting from the impact through the fifth wheel will negatively impact on the gearbox, diff, clutch, wheel bearings etc. of the truck or interlink suspension. The drivetrain and axle components now have to absorb the shock caused by inferior road conditions. The damage caused by this shock load is now transferred as wear on the expensive drivetrain and axle components.

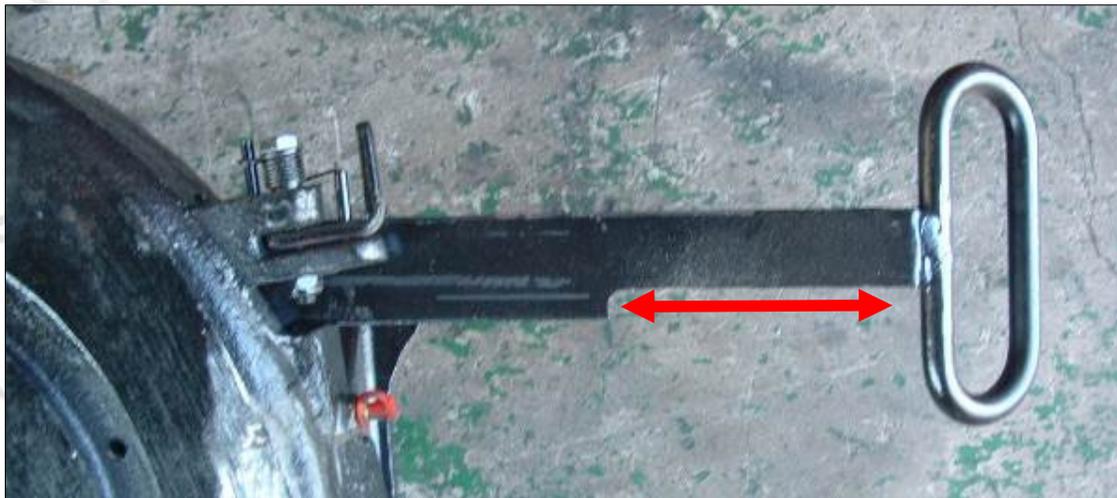
This handle has no wear indicator; even though it does have an adjusting bolt there is no way of knowing when the locking mechanism components (if obtainable) need to be replaced. Should this fifth wheel have been legal, this would unnecessarily complicate maintenance requirements.

Be careful of unknown and untraceable critical safety items. In case of a failure always ensure that those products are backed by a reputable manufacturer.
